Single Event Effect Testing of the Micron MT46V128M8

NASA Goddard Space Flight Center
Code 561.4, Radiation Effects and Analysis Group
8800 Greenbelt RD
Greenbelt, MD 20771

Test Date: July 13, 2017
Test Report Last Updated: August 25, 2017

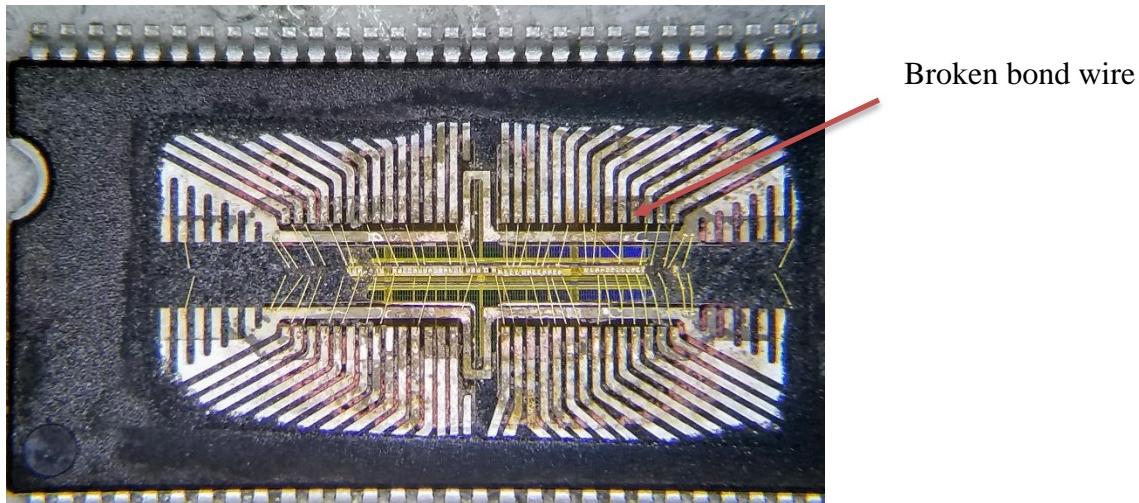
A Nisene JetEtch machine² was used to de-encapsulate the plastic package and expose the silicon die for irradiation. This was a difficult process due to the fragility of the wirebond connection to the pad frame. A mixture of Nitric and Sulfuric acid was used at approximately 90°C until a portion of die was exposed. Devices were tested for functionality after de-encapsulating and due to the aforementioned fragility, yield was low. Wire bonds at the pad frame were broken during the de-encapsulation and can be seen in Figure 1. The conclusion drawn was that the acid was eroding the pad frame beneath the bond wires and breaking the bonds.

Figure 1: DUT showing pad frame and broken bond wire

After multiple part failures in pre-testing and adapting the process, a process where a minimum of encapsulant removal reduced wire bond failure and produced functioning parts. One of the test

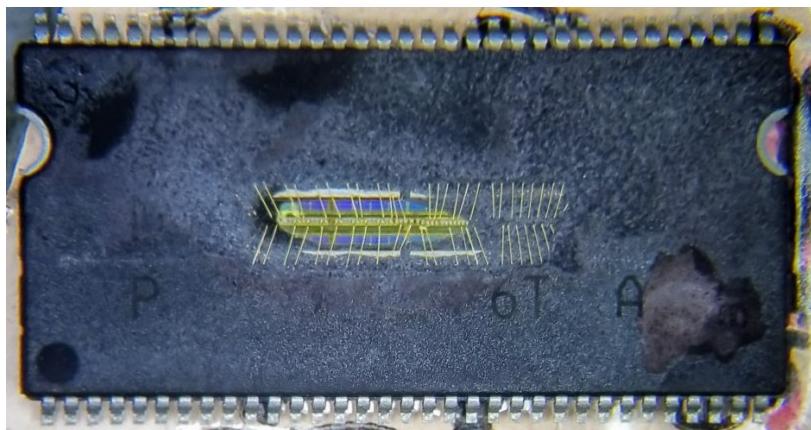
parts, DUT #1, can be seen in Figure 2. It should be noted that, due to intervening plastic and to some extent the pad frame, a large portion of the die is not able to be upset by the ion beam. After post-prep testing, four devices were deemed acceptable for evaluation.

Figure 2: Limited, functional, de-encapsulated (DUT #1) part as tested

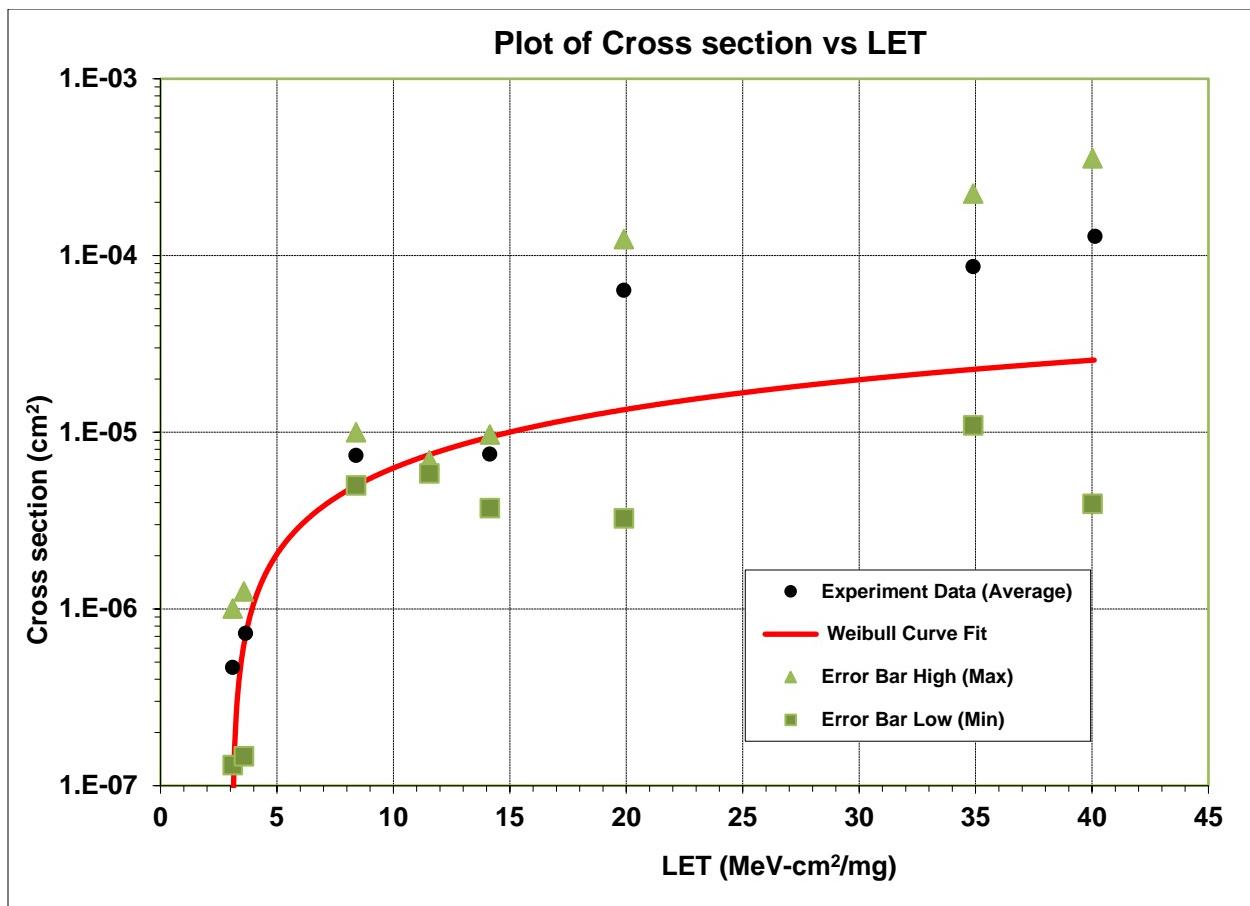
Single event upsets were reported via serial interface at 115200 baud for memory mismatches from the pre-programmed 32-bit pattern 0xAA00AA00. SEFIs requiring a power cycle to resolve were observed at each LET and generally masked any underlying single bit errors that occurred during testing. Post processing of the logs showed some limited reporting of single address upsets, but it is difficult to draw conclusions due to the large amount of SEFIs and the small window of beam exposure. Therefore, only SEFI cross sections were analyzed. The data from the processed run log is shown in Table 2 below. Figure 4 plots the cross section of SEFI onset vs. LET for the two parts tested and shows a Weibull fit (red line) of the estimated SEFI cross section with parameters A = 3.069, B = 1.28×10^{-4} , C = 0.89, and D = 200.

Figure 4: SEFI Cross section vs. LET (Weibull fit parameters $A = 3.069$, $B = 1.28 \times 10^{-4}$, $C = 0.89$, and $D = 200$)

Regardless of the above, upsets were seen in the two parts tested and a bounding of the SEFI sensitivity of the part can be estimated. From the plot above, SEFI cross section can be estimated to be less than $\sim 5 \times 10^{-4} \text{ cm}^2$.
